A CASE STUDY OF TWO AIRPORT RUNWAYS AFFECTED BY ALKALI-CARBONATE REACTION PART TWO: MICROSTRUCTURAL INVESTIGATIONS

Tong Liang * and Tang Mingshu **

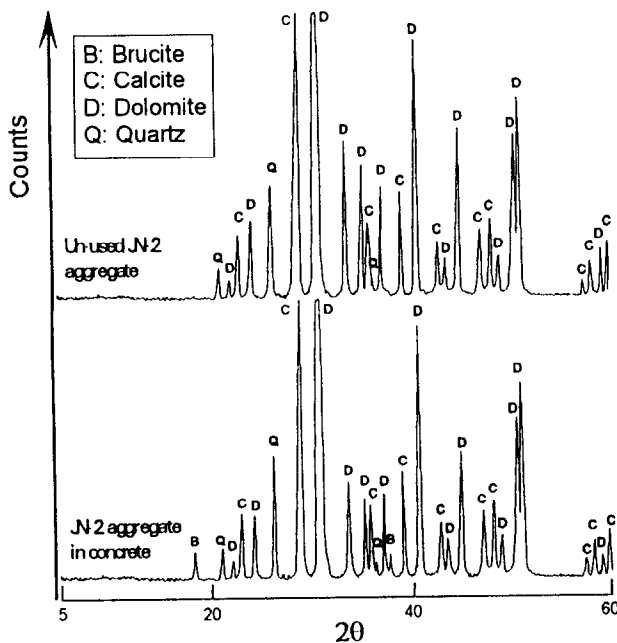
FIG. 5.

XRD pattern of JN-2 aggregate before and after used in concrete (the cracked particle in FIG. 1) shows the formation of brucite due to dedolomitization.

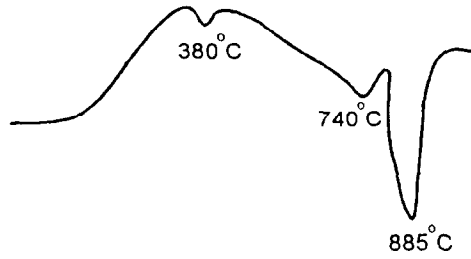
FIG. 6.

DTA curve of the cracked JN-2 aggregate particle showed in FIG. 1 in the airport (JN) concrete.

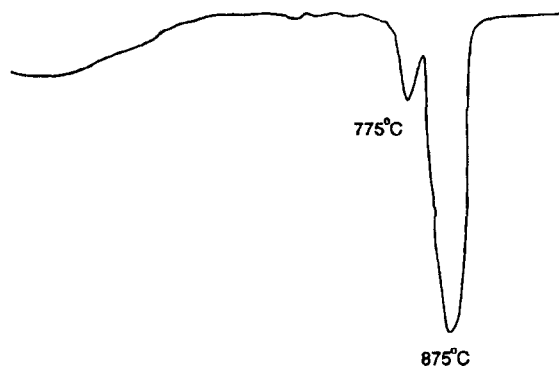
FIG. 11.

WF Airport Runway. In previous study, it was found that dolomitic limestone WB-2 used in WF airport concrete was highly reactive. It was also observed by SEM investigation that similar products formed at the interface of dolomite rhombs and surrounding matrix. WB-2 aggregate is characterized by its partial reactive texture. Rhombic dolomite crystals embedded in the matrix of fine-grained calcite and clays. The broken surface of the original WB-2 aggregate is shown in FIG. 9 and the aggregate used in the runway concrete is shown in Figure 10. Although clear evidence in FIG. 10 suggests the presence of reaction products, brucite was not detected by DTA as shown in FIG. 11 and XRD examinations in the same

aggregate particle. This may be because the amount of brucite is too small or may result from the possible reaction between brucite and silica dissolved in the alkali pore solution in the aggregate. Thus, it seems that the presence of brucite is not always a critical evidence to evaluate the occurrence of dedolomitization.

DTA curve of WB-2 aggregate used in WF airport concrete.
